Corrosion performance of mild steel and epoxy coated rebar in concrete under simulated harsh environment

Muazzam Ghous Sohail, Mohammad Salih and Nasser Al Nuaimi
Center for Advanced Materials, Qatar University, Doha, Qatar, and

Paper type Research paper

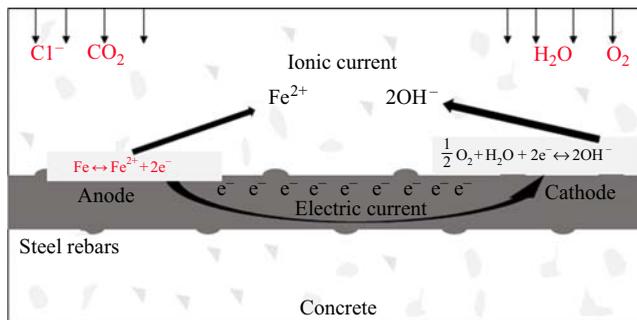
Figure 1. Corrosion process in reinforced concrete, showing anodes and cathode sites

Deterioration process in RC structures consists of two distinct time phases: initiation and propagation (Tuutti, 1982). During the initiation phase, the aggressive agents (chloride ions or the carbonation front) penetrate the concrete cover and accumulate at the steel–concrete interface. No corrosion (deterioration) occurs in this phase, which usually lasts for several years (15–20) in normal quality concrete (Yingshu *et al.*, 2007). A passive oxide layer is formed at the steel surface due to the high concrete alkalinity, which prevents steel from corrosion. The propagation phase starts when a certain level of chloride ion concentration (threshold) reaches the steel–concrete interface or when concrete cover is carbonated, which lowers the pH of pore solution; as a result of these two phenomena, the passive layer becomes unstable and it is destroyed, initiating the corrosion process (Poon and Baldwin, 1990; Angst *et al.*, 2012; Sohail *et al.*, 2015; Tasker, 1985). The service lifespan of RC structures shortens once corrosion is initiated. The corrosion is a natural phenomenon in which steel tends to revert back to oxide form on the availability of suitable environments (i.e. presence of oxygen (O_2) and humidity (H_2O)). Corrosion process follows electrochemical laws wherein two half-cell reactions occur simultaneously at steel surface, as shown in Figure 1, the iron oxidation at anode sites

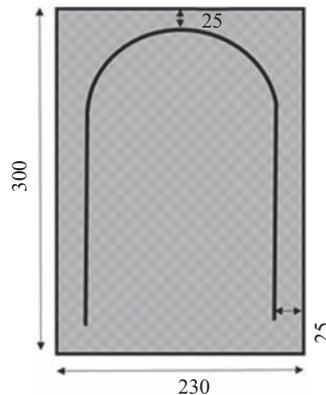
Note: All dimensions are in mm

Figure 2.
Schematic of concrete
block samples with
U-shaped
reinforcement steel
bars at the middle

To evaluate the corrosion behavior, 16 mm diameter U-shaped mild steel BB, ECR or ECRCD were, respectively, embedded at the middle of concrete block samples of 230 mm × 300 mm × 70 mm dimensions. Figure 2 schematically presents the sample geometry. The U-shaped bent was provided to observe the effect of stress-induced corrosion on BB and the disbondment of epoxy and its effects on ECR corrosion. The ECRs were used in two conditions, as received (ECR) and with 3 mm diameter circular damage in epoxy at three locations (ECRCD). Three concrete block samples for each type of reinforcement were cast and designated as: BB-1, BB-2, BB-3, ECR-1, ECR-2, ECR-3, or ECRCD-1, ECRCD-2, ECRCD-3, respectively.

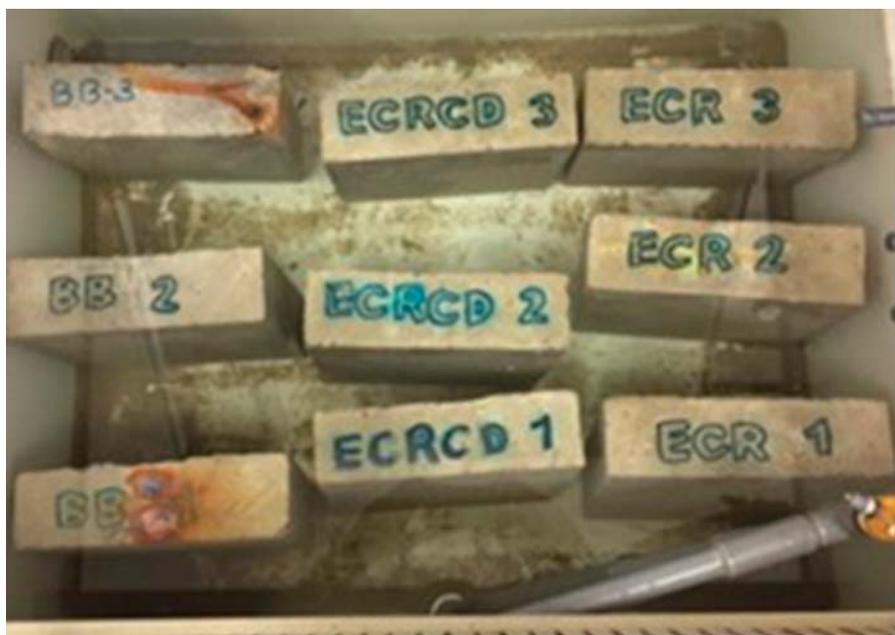
Plate 1.
Concrete block
samples under Gulf
seawater inside a salt
spray chamber

Concrete samples were cured by immersion under water for 28 days. Then the southern exposure conditions (Virmani *et al.*, 1983; Funahashi, 1990) were applied by placing the samples in a salt spray chamber filled with 3.89 percent NaCl^- solutions (i.e. Arabian Gulf seawater) (Plate 1). Cycles of four days of ponding at 16–27°C, followed by three days of heating and drying at a target temperature of 52°C, were applied. This was to simulate the severe corrosive environments, especially encountered in marine tidal zones. These cycles continued for twelve weeks, then the continuous ponding under seawater at a target temperature of 32°C, for the following 12 weeks, was applied. This 24-week cycle was repeated 4 times for a total exposure time of 96 weeks. With wetting and

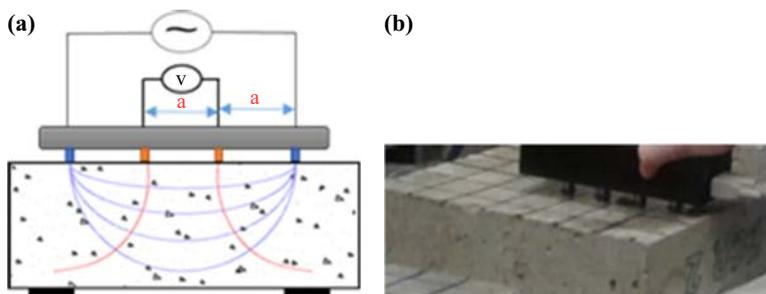
Figure 3.
(a) Schematic of resistivity measurements concept; (b) resistivity measurements on concrete blocks by Giatec® meter

2.3.1 Concrete resistivity. The resistivity is a measure of concrete quality and an indicator of the corrosion risk (Polder and Hug, 2000). The lower the concrete resistivity, the higher will be the risk of corrosion, as the flow of ions (Fe^{2+} , OH^-) would be easier through concrete pores (Nagi and Whiting, 2004). The concrete surface resistivity was measured using Giatec® resistivity meter, which is based on four-point Wenner probe, thereby conforming with AASHTO TP 95 (2011). Figure 3(a) schematically presents the concept of measurement, whereas Figure 3(b) shows the measurements on concrete blocks. The bulk concrete resistance is measured in Ohms by injecting electrical current (I) through external electrodes and potential difference (V) is observed by central two electrodes (Figure 3). Resistivity of concrete was then obtained by Equation (3):

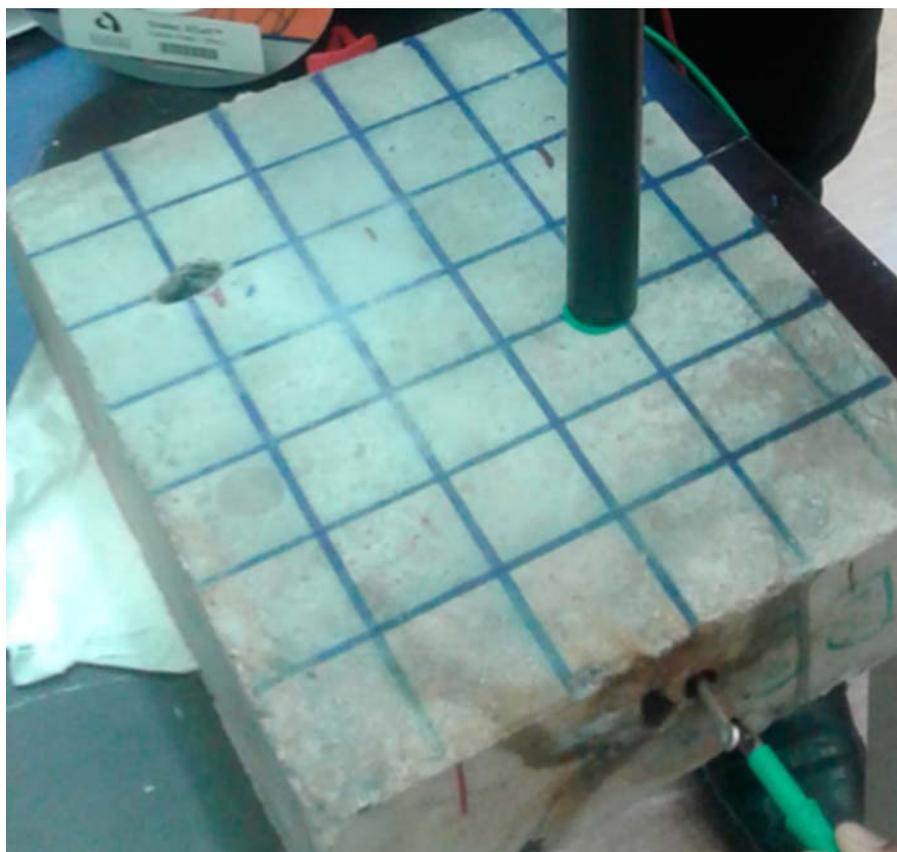
Plate 2.
Half-cell potential
measurements on
concrete blocks using
Cu/CuSO₄ as the
reference electrode

2.3.3 Half-cell potential. The half-cell potential (HCP) values distinguish the active and passive corrosion zones on a concrete reinforcing steel bar. It is measured against a reference electrode (RE) according to ASTM C876-09 (2015). The Giatec® HCP measuring equipment, which uses copper/copper-sulfate (Cu/CuSO₄) (CSE) as an RE, was used in this study. Concrete blocks were marked by grids of 4 cm × 4 cm to get HCP contour mapping (Plate 2). The concrete block samples BB-1, BB-2 and BB-3 were drilled till rebar established an electrical connection (Plate 2). In case of ECR and ECRCD, the HCP measurements are not possible until the epoxy is removed and a direct connection to underlying steel is established; hence, concrete was removed from one corner to expose the rebar and then the epoxy was peeled off from a small portion. A concrete block sample for each type of reinforcement (BB-1, ECR-1 and ECRCD-1) was broken after HCP measurements for visualizing the corrosion state and epoxy condition.

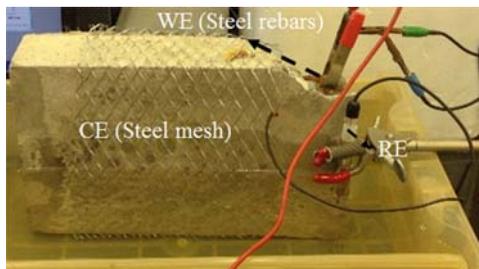
Figure 4.
Three-electrode setup
for Tafel plots

2.3.5 Tafel Plot. Tafel and Stern (1905) proposed that the logarithm of current varies with electrode potential (i.e. $\log I \sim E$) in an electrochemical reaction. A polarization of ± 200 mV is applied to metal from corrosion potential (E_{corr}) and a logarithmic response of current, I , is recorded. The extrapolation of these curves yields the corrosion parameters like I_{corr} , anodic Tafel slope constant β_a , and cathodic Tafel slope constant β_c . From I_{corr} , the corrosion current density i_{corr} is calculated by $\Delta I/S$, where S is the polarized steel surface area. The i_{corr} has units of microamperes per centimeter square ($\mu\text{A}/\text{cm}^2$).

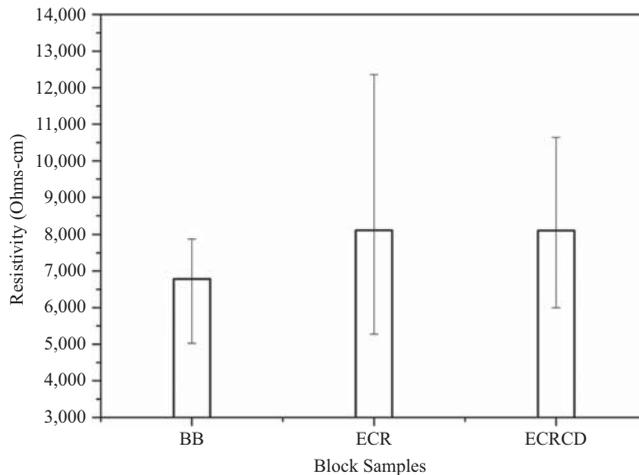
Figure 7. Resistivity values measured at concrete samples after two years of immersion in seawater

Figure 7 presents the measured resistivity of a C40 concrete after two years of exposure under seawater. Column bars have an average resistivity from three blocks having similar reinforcement, whereas error bars show maximum and minimum values. An average resistivity over nine samples was 7,670 Ω-cm, with minimum and maximum of 5,024 Ω-cm (BB) and 12,362 Ω-cm (ECR), respectively. The resistivity of concrete samples reinforced with mild steel BB was lower than the one reinforced with ECR. This could be due to the cracking induced in concrete by heavy corrosion products. Table III presents the corrosion risk associated with concrete resistivity suggested by different researchers from open literature (Song and Saraswathy, 2007). Most concrete blocks had resistivity values at which the corrosion risk is high to very high. Given the lower resistivity and presence of moisture, the concretes under marine environment have higher diffusivity to ions like Fe²⁺, Cl⁻ and OH⁻, hence the risk of corrosion becomes higher in such conditions.

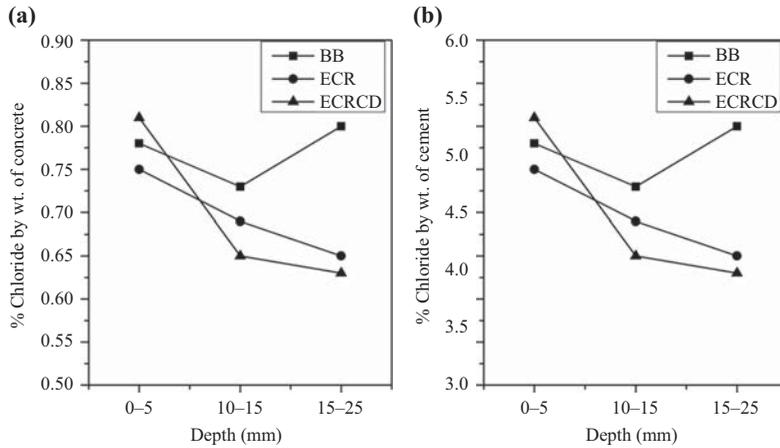
Notes: (a) % by wt. of concrete; (b) % by wt. of cement

Figure 8.
Chloride profile in
blocks samples

Figure 8 presents the chloride ion concentration along the depth of concrete blocks. Generally, the concentration of chlorides decreases from a maximum value at the outer surface to a minimum value at the middle of the concrete member. The thickness of concrete blocks was 70 mm, whereas the clear cover was only 25 mm, and several (48 in total) wetting and drying cycles were applied for two years, hence the chloride profiles were observed to be quasi-constant till steel surface. Minimum chloride

concentration near the steel surface was at least 0.63 percent by weight of concrete in all samples, whereas the maximum value was 0.80 percent. Figure 8(b) shows the % chloride contents against the weight of cement. The risk of corrosion of steel rebar increases with chloride ions concentration. According to (Broomfield, 2007) 0.4 percent of chloride by weight of cement is the threshold value for corrosion to be initiated. Some other researchers (Funahashi, 1990) suggested the Cl⁻ threshold of 0.17 percent by weight of cement; however, a threshold of 0.2 and 0.25 percent is also mentioned in other literature (Glass and Buenfeld, 1997). Table IV shows the risk of corrosion involved with chloride ions concentration with respect to the total mass of both concrete and cement, respectively (Broomfield, 2007). For a high risk of corrosion, chloride concentration is suggested as 0.14 percent by weight of concrete.

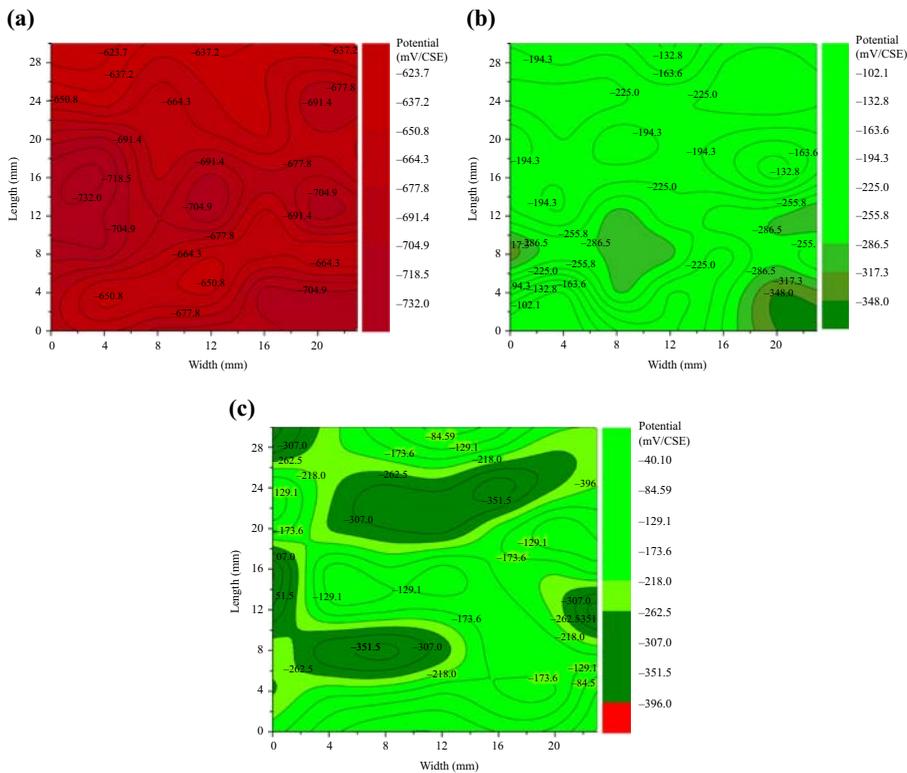
Figure 9. Half-cell potential measured

Notes: (a) BB-3; (b) ECR-3; (c) ECRCD-3

Figure 9 shows the half-cell potential (HCP) contour mapping on the surface of BB-3, ECR-3 and ECRCD-3. The whole surface of the concrete block gave potential below -600 mV/CSE with a minimum HCP value of -732 mV/CSE. ASTM C876-09 (2015) standard suggests severe corrosion at BB (Table V). Corrosion products were visible at the surface of BB samples, especially at the side where reinforcement had a bent. The HCPs at ECR and ECRCD were observed to be in the range of -40 mV/CSE to -350 mV/CSE, as shown in Figure 9(b) and (c), respectively. These potentials are less electronegative compared to mild steel BB. This shows that ECR and ECRCD were in passive state and high chloride concentration was not able to damage or penetrate through the epoxy coating. According to ASTM C876-09 (2015), the probability of corrosion at these HCPs values is low (Table V).

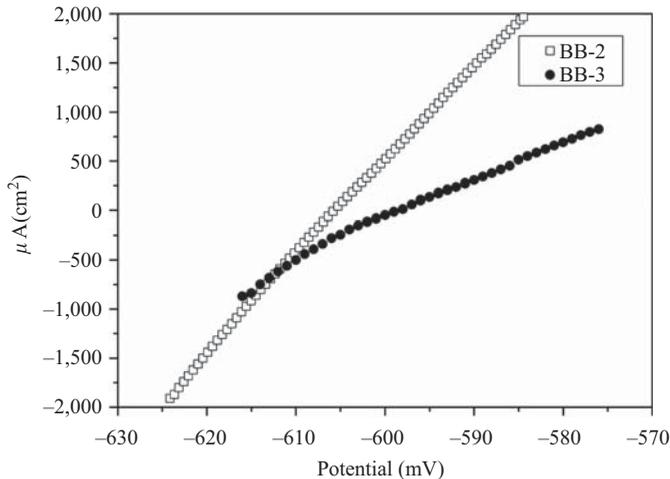
Figure 10. R_p of mild steel bare bar samples, BB-2 and BB-3

Figure 10 shows the polarization curves for samples BB-2 and BB-3 obtained in LPR technique. LPR was not used for ECR and ECRD samples, as DC current could not pass through the epoxy coating. R_p values of 4.5 and 7.75 $k\Omega\text{ cm}^2$ were observed for BB-2 and BB-3, respectively. Passive steel shows an R_p value above 230 $k\Omega\text{ cm}^2$ (Vedalakshmi and Palaniswamy, 2010); below this value, the corrosion initiation is imminent. Hence, severe corrosion is associated with such lower polarization resistance.

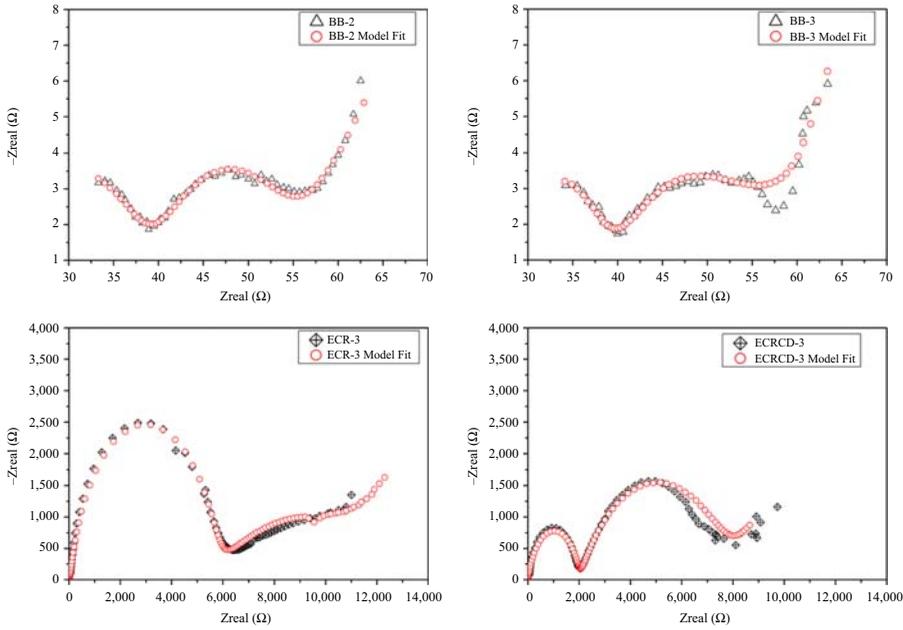
Figure 11. Nyquist plot for a mild steel bare bar, ECR and ECRCD

Nyquist plots for BB, ECR and ECRCD from EIS scan are shown in Figure 11. Depending upon the configuration of the interfaces in RC, the response is compared to an equivalent circuit model to obtain the parameters like R_c , R_{ct} , resistance of the epoxy coating, R_2 (R_{EP}) and capacitance, C_p . Figure 12 shows the equivalent circuit model used to fit the experimental EIS curves. Three capacitive arcs, i.e., three-time constants, appear at different frequency ranges. Due to the heterogeneity of concrete and roughness of electrode surface, the interfaces do not act as pure capacitors; hence, the semi-circles are overlapping and depressed below the real axis in the Nyquist plot. For this reason, instead of using a pure capacitor in the circuit, a constant phase element (CPE), Q_i , is added that allows the best fitting of the curve (Figure 12). Capacitance from CPE was then calculated by Equation (8). The obtained parameters are shown in Table VI. The curves of BB are similar in behavior, at the lower frequencies, the impedance of electrode reactions is observed providing R_{ct} . The values of R_{ct} in case of BB-2 and BB-3 were 6.02 and 9.03 $k\Omega\text{ cm}^2$, respectively. The middle arc is due to oxide and concrete micro-structure at the steel surface. Some researchers attributed this middle arc to the lime precipitation at the steel surface with an oxide layer (Dhouibi-Hachani *et al.*, 1996; Lay *et al.*, 1985). In carbonated concrete where lime is consumed in the carbonation process, this arc does not appear. In

the case of ECR, the middle arc provides the characteristics of the epoxy layer. ECR and ECRCD show different behaviors in this region. The resistance of the epoxy coating was 1,784 and 604 $k\Omega cm^2$ in ECR and ECRCD, respectively. Lower resistance in ECRCD shows that the EIS technique was able to detect the defects in epoxy, and hence can be a useful tool in accessing the epoxy condition and corrosion of underlying steel. At this frequency range, the block samples with BBs showed resistance of 6 and 24 $k\Omega cm^2$, that is, the resistance offered by oxide and lime layer precipitated at steel surface. The R_{ct} values of ECR and ECRCD samples were 1,673 and 1,675 $k\Omega cm^2$, respectively, which is a very high resistance to charge transfer, showing that the underlying steels are in a passive corrosion state. An inclined upward line at the right of Nyquist plot shows the Warburg

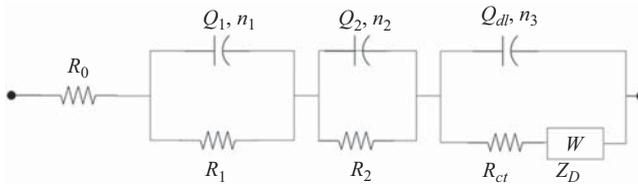
Figure 12. Equivalent circuit model for EIS spectra

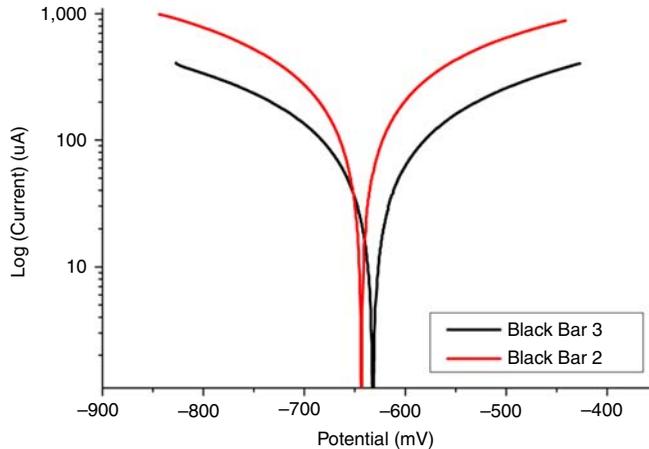
Figure 13. Tafel plots (polarization curves)

Figure 13 shows the Tafel plot of BB-2 and BB-3 obtained by applying polarization of ± 200 mV. Extrapolation of these curves gives the corrosion current (I_{corr}) and the anodic and cathodic Tafel slopes, β_a and β_c , respectively. Results are presented in Table VII. Corrosion current densities were observed to be 1.24 and $0.40 \mu\text{A}/\text{cm}^2$ on BB-2 and BB-3, respectively. The β_a was 420 millivolts per decade (mV/dec) and 440 mV/dec, whereas β_c was 438 and 415 mV/dec for BB-2 and BB-3, respectively. The slope of the linear portion of the Tafel plot indicates the rate of corrosion reaction: steeper the slope, higher is the rate of corresponding half-cell reaction. Table VIII lists the corrosion severity with respect to the measured corrosion current density. The corrosion current densities were in the range of moderate to high or very high. These corrosion parameters form Butler–Volmer equation, which alongside Ohm’s law are used to model the corrosion phenomenon in RC

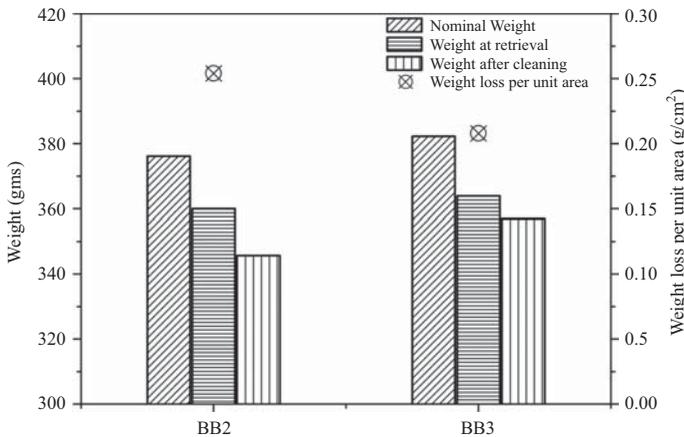
Figure 14. Weight loss of cut pieces of steel bars from BB-2 and BB-3

Figure 14 compares the weight at retrieval and after cleaning of cut steel pieces against their nominal weights. To normalize, the weight loss per unit area (g/cm^2) was calculated. The weight losses of 0.254 and $0.207 \text{ g}/\text{cm}^2$ on BB-2 and BB-3, respectively, were observed. A higher weight loss on BB-2 than BB-3 is in accordance with the results of LPR, EIS and Tafel plots in which the corrosion current density was also higher in BB-2 than BB-3.

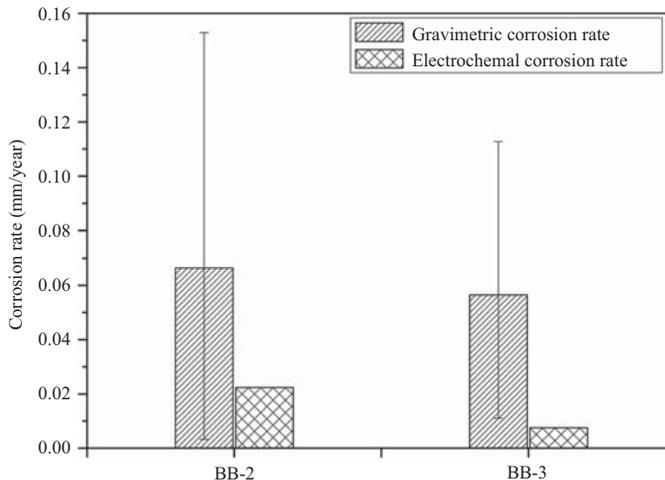
Figure 15. Corrosion rate through gravimetric weight loss and corrosion current density at BB-2 and BB-3

Figure 15 presents the comparison of corrosion rate in mm/year on cut steel pieces through gravimetric method against the one calculated from corrosion current density measured by electrochemical techniques. On the steel pieces from BB-2, the average, maximum and minimum corrosion rates through gravimetric method were 0.06, 0.153 and $0.00327 \text{ mm}/\text{year}$, respectively (Figure 15). For BB-3, these values were 0.0565, 0.113

and 0.0111 mm/year, respectively (Figure 15). The corrosion rates from electrochemical method were 0.0224 and 0.00747 mm/year for rebar from BB-2 and BB-3, respectively.

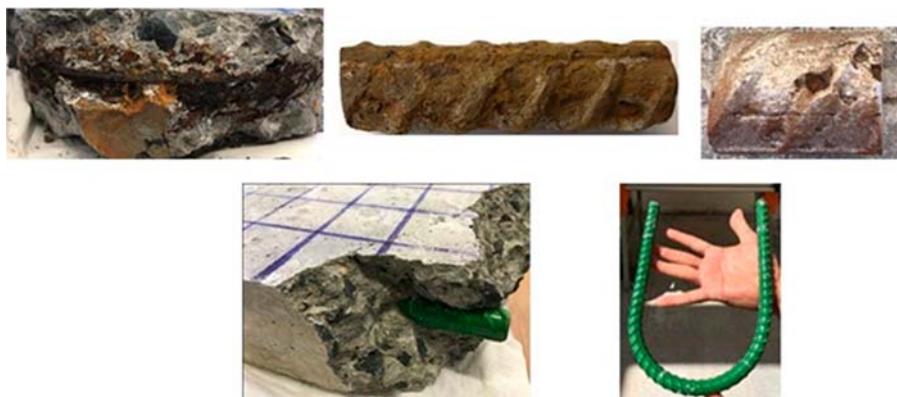
Plate 3.
Visual inspection of corrosion conditions of BB, ECR and ECRCD in concrete blocks and after retrieval

An adhesion number of 1 was observed in knife-peel tests; the epoxy coating was hard to cut through by the knife blade. Epoxy coating of ECR and ECRCD was strongly intact and no change in coating color was observed after two years of immersion. There was no evidence of steel corrosion under the epoxy coating. Plate 3 shows the corrosion conditions of ECR and BB after retrieval. Mild steel BB suffered severe corrosion and the rust products migrated into the adjacent concrete. Further, the U bent portions showed severe corrosion and the rust products were visible at the outer surface of concrete blocks, whereas the ECR and ECRCD were not affected by chlorides and moisture, the epoxy was in shining green color, no disbondment at the bent portion, and no corrosion of underlying steel was observed.
